DEPARTMENT OF TRANSPORTATION**DIVISION OF ENGINEERING SERVICES**

Contract #: 04-0120F4Cty: SF/ALA Rte: 80 PM: 13.2/13.9File #: 1.28**WELDING INSPECTION REPORT****Resident Engineer:** Casey, William**Address:** 333 Burma Road**City:** Oakland, CA 94607**Report No:** WIR-027373**Date Inspected:** 26-Mar-2012**Project Name:** SAS Superstructure**OSM Arrival Time:** 700**Prime Contractor:** American Bridge/Fluor Enterprises, a JV**OSM Departure Time:** 1730**Contractor:** American Bridge/Fluor Enterprises, a JV**Location:** Job Site**CWI Name:** Bernie Docena**CWI Present:** Yes No**Inspected CWI report:** Yes No N/A**Rod Oven in Use:** Yes No N/A**Electrode to specification:** Yes No N/A**Weld Procedures Followed:** Yes No N/A**Qualified Welders:** Yes No N/A**Verified Joint Fit-up:** Yes No N/A**Approved Drawings:** Yes No N/A**Approved WPS:** Yes No N/A**Delayed / Cancelled:** Yes No N/A**Bridge No:** 34-0006**Component:** SAS Tower**Summary of Items Observed:**

WELDING INSPECTION REPORT

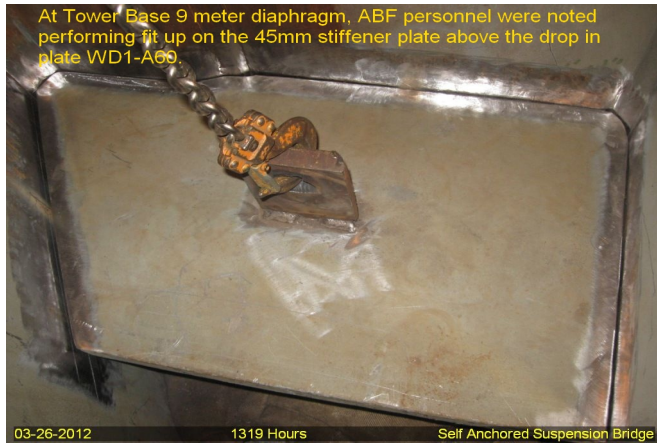
At Tower Base 9 meter outer East external diaphragm WD1- A60 drop in plate, ABF qualified welder Wai Kitlai was observed continuing to perform 1G (flat position) welding the fill pass on weld joint #057 (3 & 4) and #059 (2) using the Flux Cored Arc Welding (FCAW-G) with E71T-1M, 1/16" diameter wire electrode and implementing Caltrans approved Welding Procedure Specification (WPS) ABF-WPS-D15-3160-1. This QA Inspector observed ABF personnel using Miller Proheat 35 Induction Heating System to preheat the plates being welded prior to and after welding. This QA Inspector observed QC Inspector Bernie Docena using a Fluke infra red temperature gauge to verify the preheat temperature of more than 325°F. This QA Inspector performed a verification of the welding parameters and observed 290 amperes and 24.0 volts. During the shift, the welder has completed the PJP weld T-joints and butt joint and right after the welding completion, ABF personnel were noted covering the weld joints with heater blanket in preparation for the three hours holding of preheat temperature of more than 325°F as required. ABF personnel were using Miller Proheat 35 Induction Heating System to hold the preheat.
